UNDERWATER BRIDGE INSPECTION REPORT

STRUCTURE NO. 66513
14th STREET (MSAS NO. 103)
OVER THE
STRAIGHT RIVER
DISTRICT 6 - RICE COUNTY

PREPARED FOR THE
MINNESOTA DEPARTMENT OF TRANSPORTATION
BY
COLLINS ENGINEERS, INC.
JOB NO. 5221

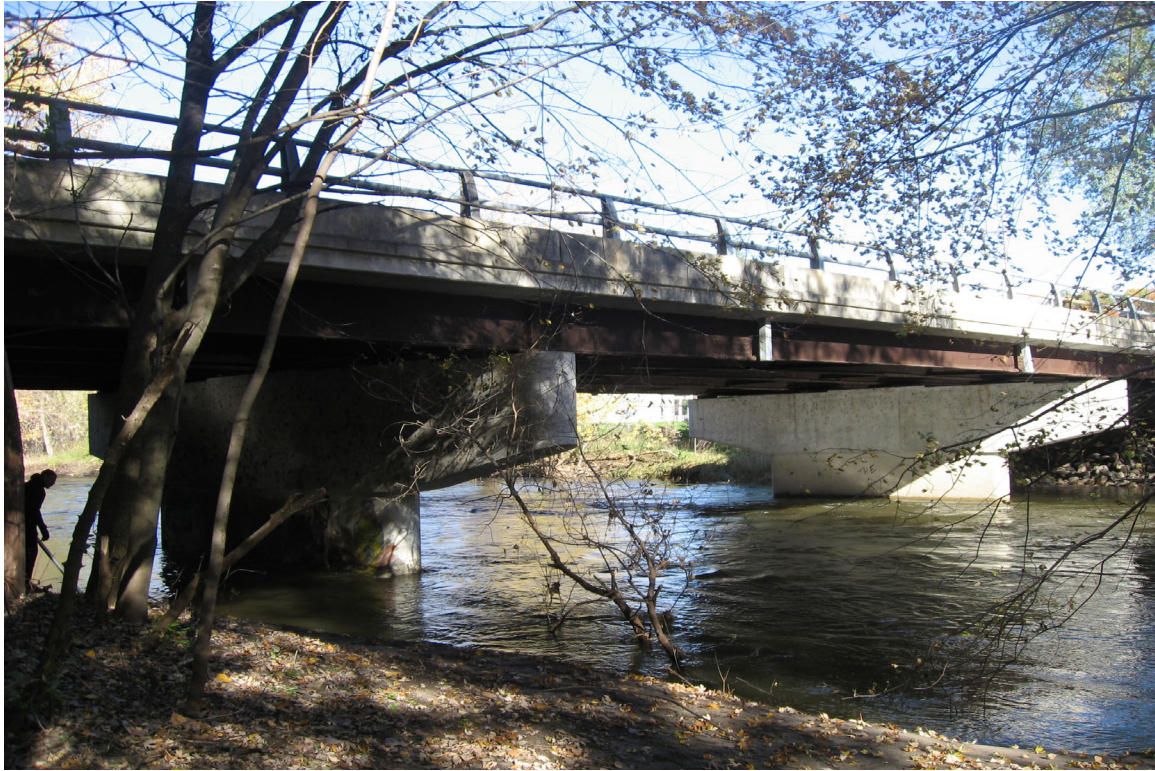
Photograph 1. Overall View of the structure, Looking Northeast.

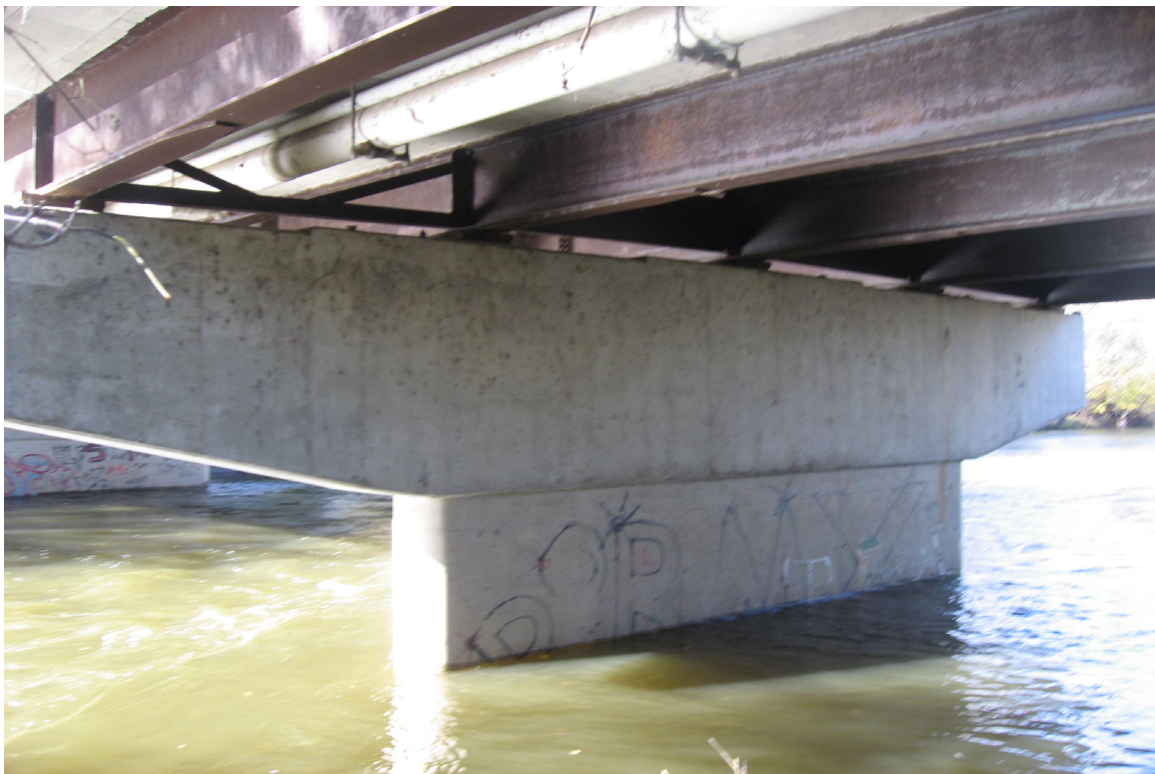
- (A) Concrete of both pier shafts was in smooth, sound and good condition with no notable deterioration.
- (B) A light accumulation of timber debris consisting of branches 3 inches and smaller was observed at the upstream end of the West Pier, extending from the channel bottom up 1 foot.

Photograph 2. View of East Pier, Looking Northwest.

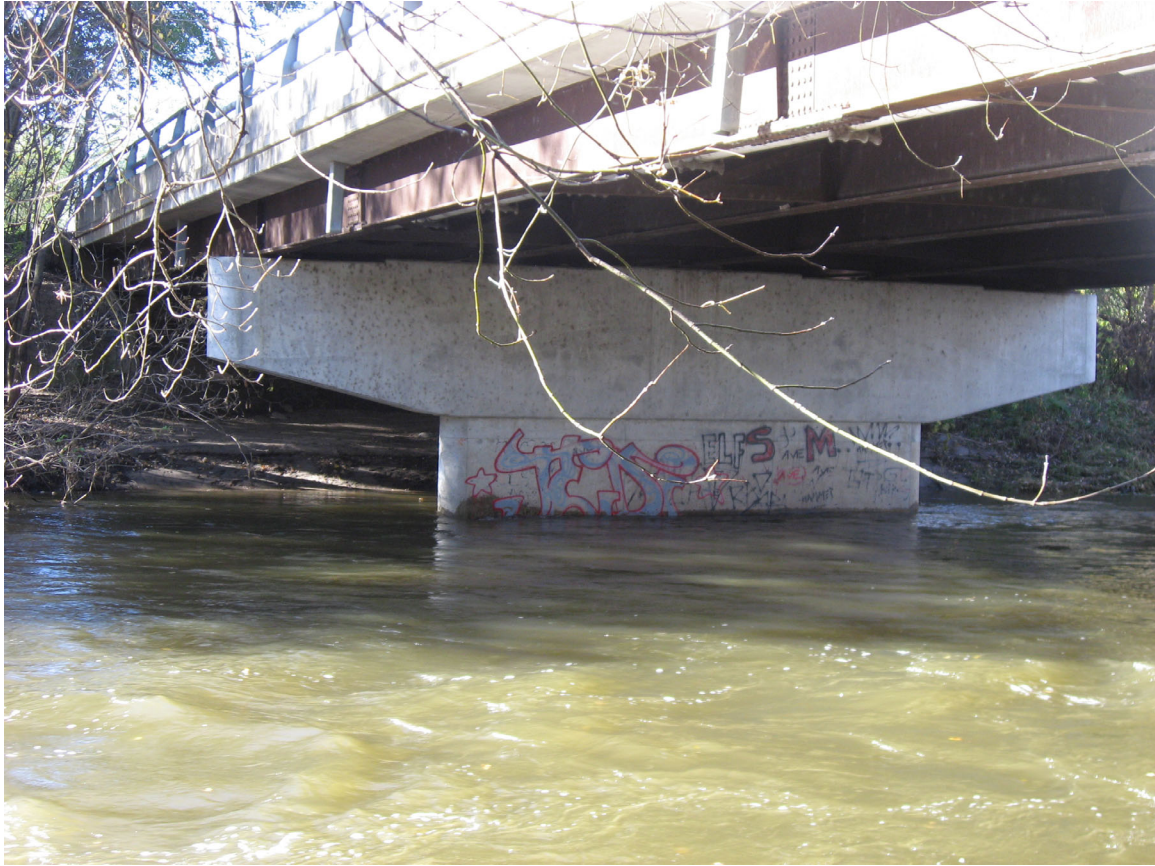
The substructure units inspected at Bridge No. 66513, East and West Piers, were sound and in good condition with no structurally significant defects observed. A light accumulation of timber debris was observed at the upstream end of the West Pier. The channel bottom appeared stable with no appreciable scour.

Photograph 3. View of West Pier, Looking Northwest.

- (A) Reinspect the submerged substructure units at the normal maximum recommended (NBIS) interval of five (5) years.

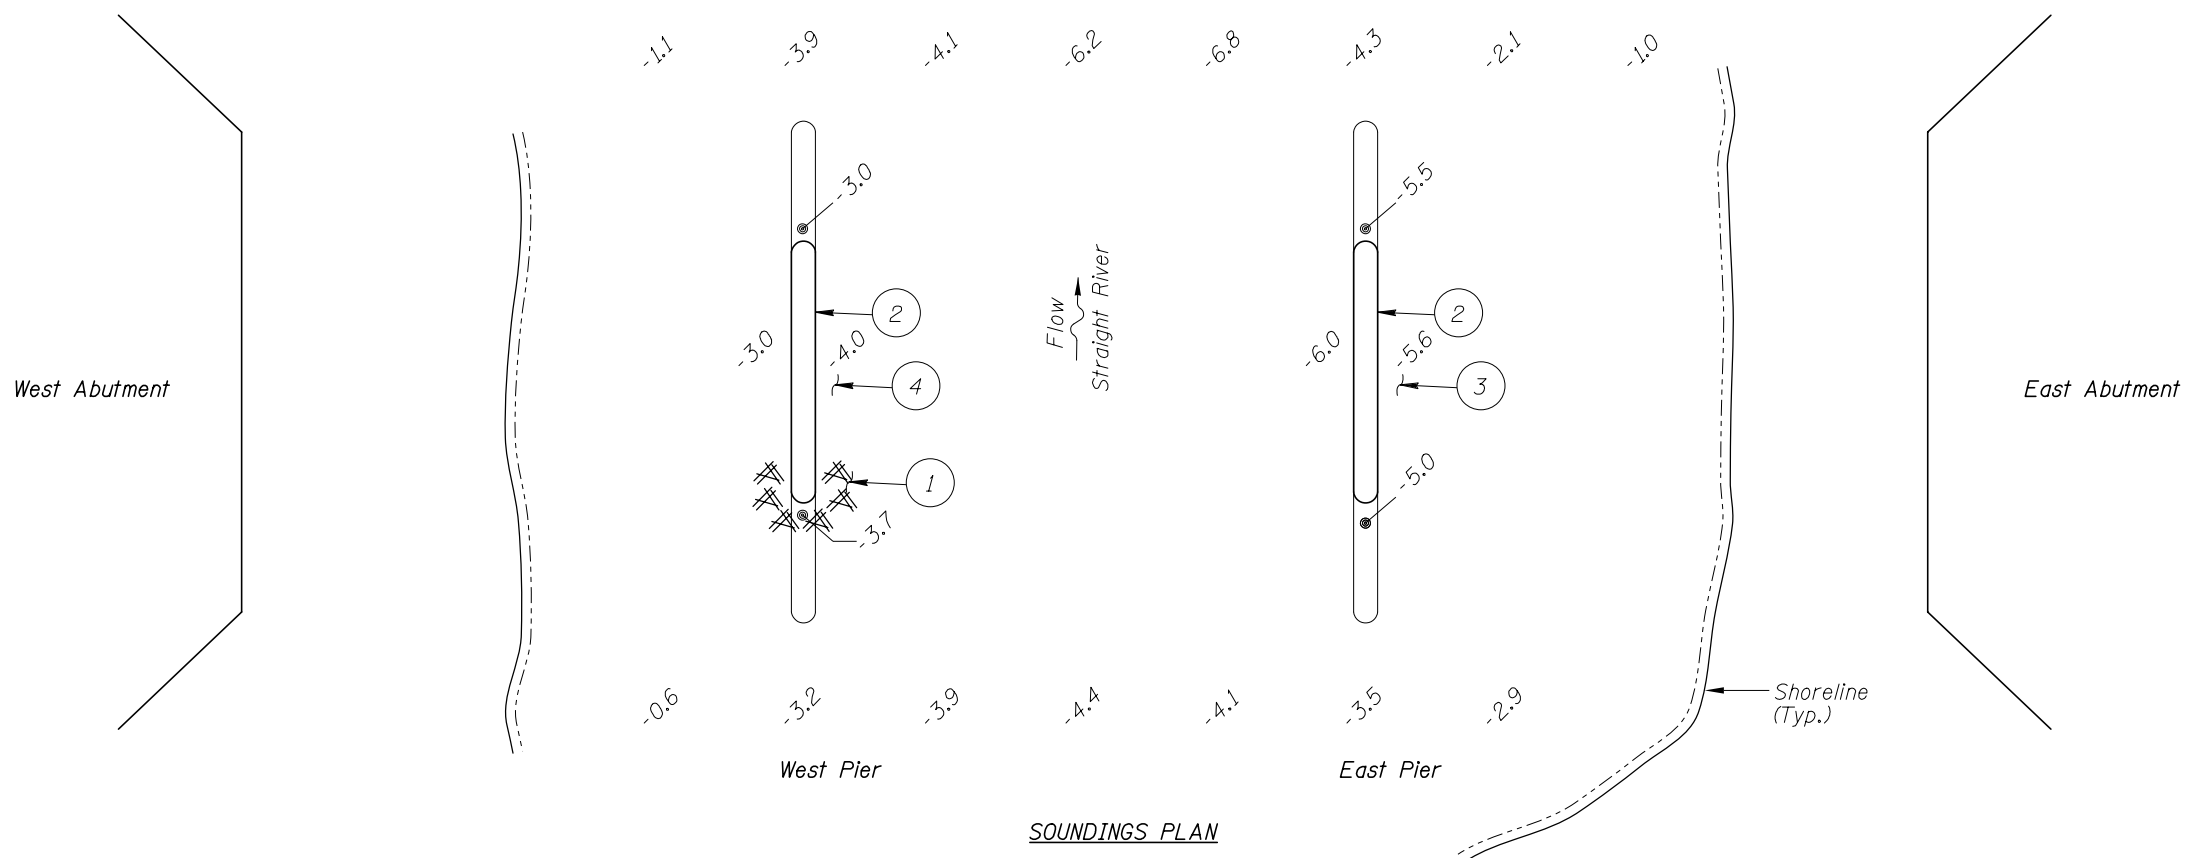
INSPECTION AND SOUNDING PLAN

- 1 A light accumulation of timber debris consisting 3-inch-diameter and smaller branches was observed at the upstream end of West Pier from the channel bottom up 1 foot.
- 2 The concrete was in smooth and sound condition with no notable deterioration.
- 3 Channel bottom around the East Pier consisted of rock with no probe rod penetration.
- 4 The channel bottom around the West Pier consisted of rock, gravel, and sand from the upstream end to the pier midpoint with no appreciable probe rod penetration and sand and silt with 6 inches of probe rod penetration along downstream half of the pier.
